NUCLEAR WEAPONS EFFECTS TESTS  
OF BLAST TYPE SHELTERS

A Documentary Compendium of Test Reports

# **NUCLEAR WEAPONS EFFECTS TESTS OF BLAST TYPE SHELTERS**

**A Documentary Compendium of Test Reports**

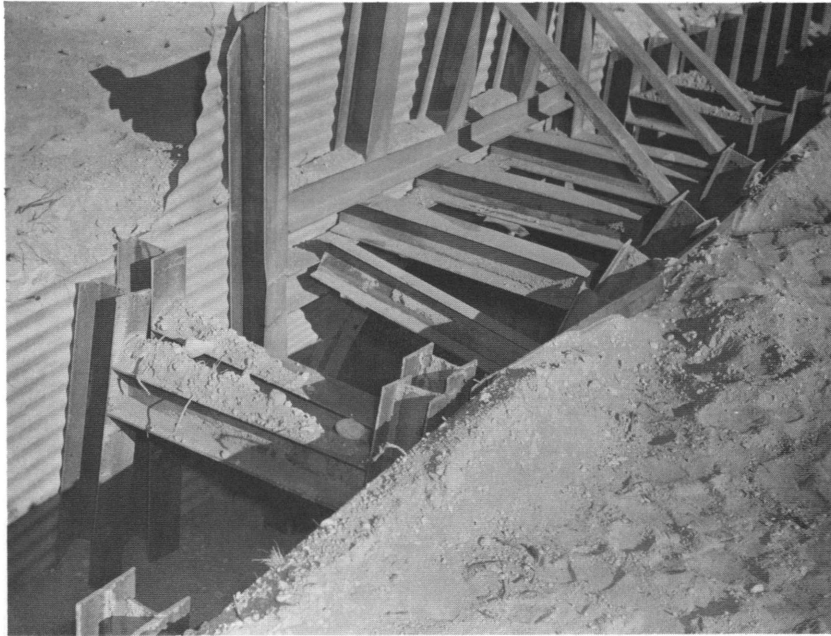
No damage was observed in the metal-pipe sections; however, structural members in the metal ramp suffered considerable damage and deformation. Light to moderate damage was observed in the concrete pipe; many cracks and considerable spalling were apparent in parts of the concrete ramp.

Fig. 6—Close-up view showing collapse of steel ramp wall after Dog shot.

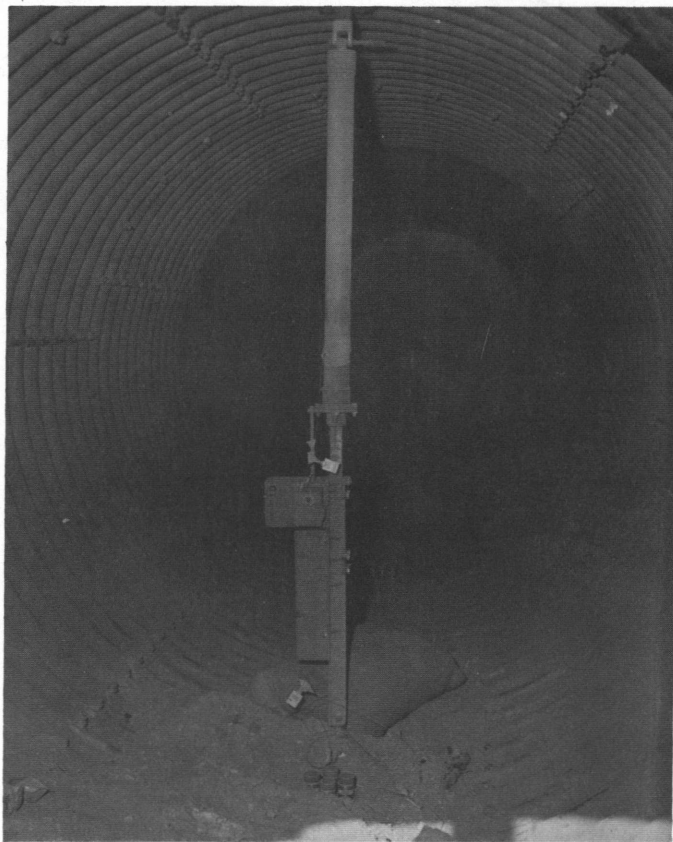
Structural damage caused by Charlie shot, the first detonation of any consequence, showed the following: A considerable amount of the mounded earth cover was removed, and large quantities of soil flowed down the ramps and sloped into the pipe ends, reducing the clear-opening area by 20 to 30%.

The displacements of the 50-lb earth-and-sawdust-filled burlap bags (simulated dummies) tested under Charlie and Dog shots, as well as their orientations after overturning, indicated the behavior of the reflected pressures. After Charlie shot the dummies were found in the following positions, reading from the steel (south) end to the concrete (north) end (Fig. 7):

Dummy 5, 14 ft from center, moved 10 in. north, bag broken, with top to north.

Fig. 7—General interior view facing north, showing instrumentation, dummies, and debris after Charlie shot.

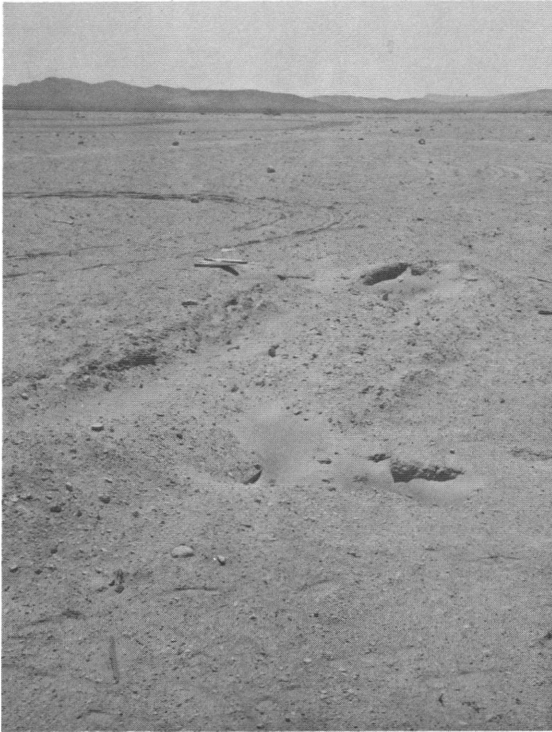
**Fig. 2—Uncovered shelter remains at position 1.**

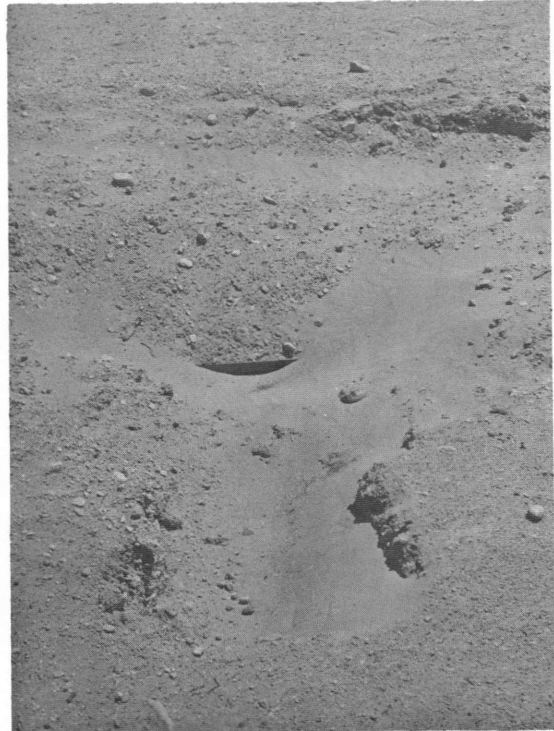
The covered shelter collapsed entirely. Portions of the wood showed signs of severe charring. Figure 3 shows the filled-in rear entrance and part of the charred wood covering of the shelter. On the basis of the charring of the wood ceiling inside the shelter, it was assumed that occupants of such a shelter under similar conditions would receive severe third-degree burns over all areas of exposed skin and also burns of a lesser degree over covered portions of the body. The total prompt-gamma dose was probably 7000 to 11,000 r. Film badges could not be recovered since collapse of the shelter was total. It is doubtful if any survivors could be expected in a similar shelter subjected to similar atomic effects conditions.

**Fig. 3—Filled-in rear entrance at position 1.**

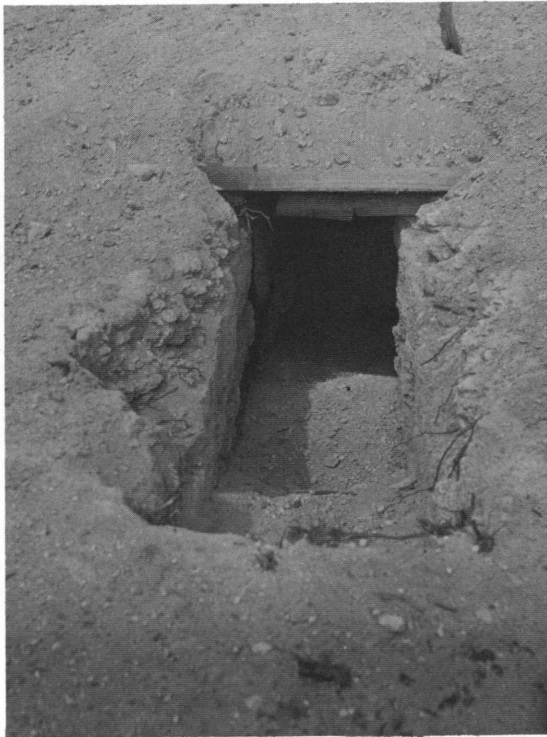
**Fig. 4—Front entrance to covered shelter at position 2.**

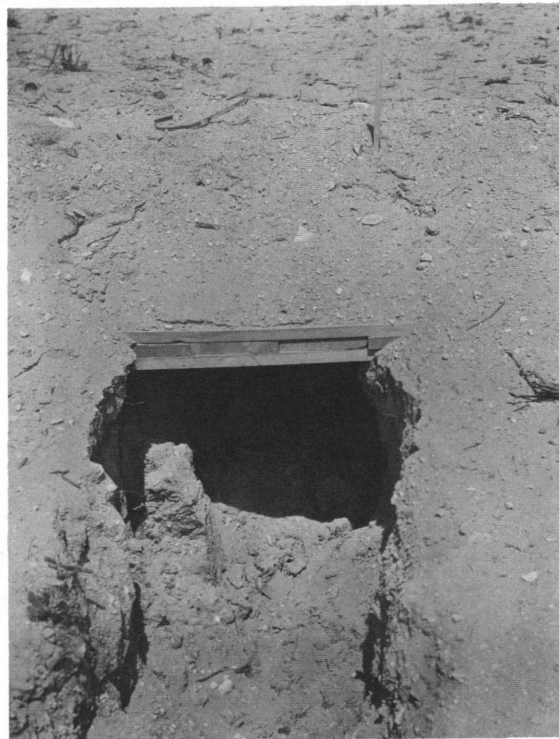
\*Caused by poor soil structure and lack of revetment.

**Fig. 5—Rear entrance at position 4.**

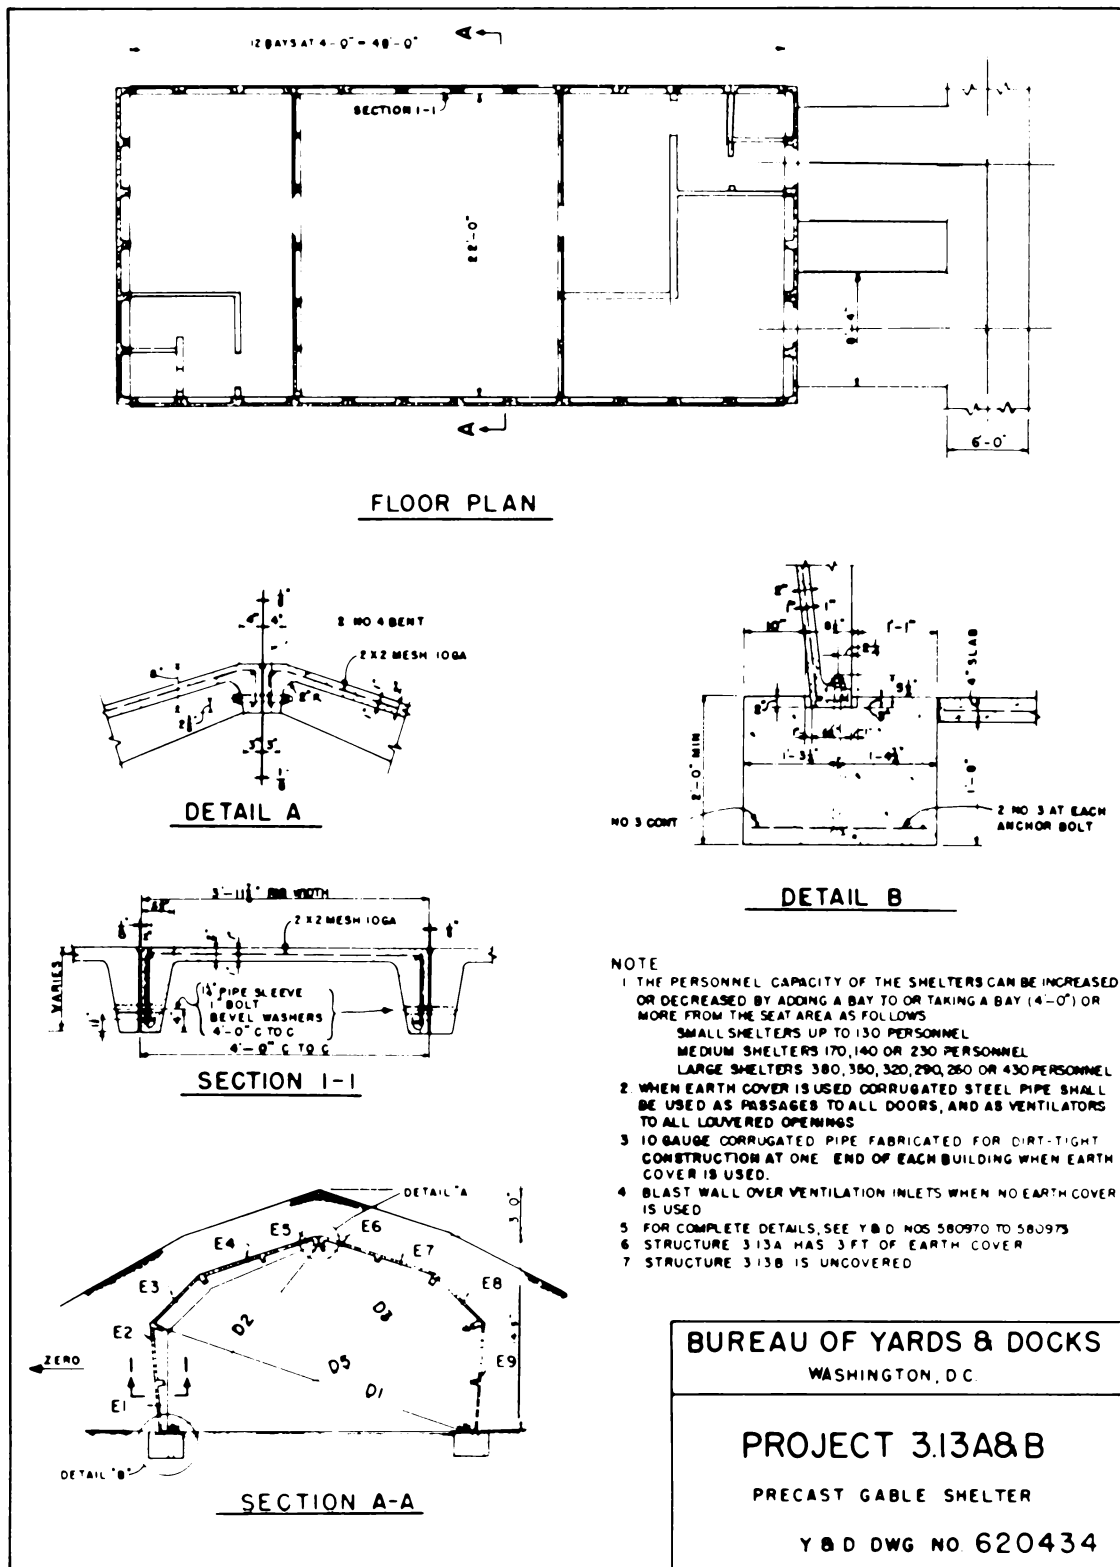
Fig. 1—Details of design, structure 3.13.

1. The precast concrete gable building (3.13a), when covered with earth to a 3-ft depth, remained in operational condition and would have provided satisfactory protection during the two shots.

2. The main building remained within the elastic range. The primary mode of deflection appeared to be crown down, haunches out. Small cracks were observed in the end panels and the associated vertical beams.

Regarding structure 3.13a it seemed clear in a general way that earth cover was beneficial. This was evident in the fact that the postshot survey indicated wider cracks in the end walls after 8 psi on shot 10 without earth cover than were produced by 11 psi on shot 9 with earth cover. In general, the benefit of the earth cover on this type of building is reduced because the framing design is much more rigid and consequently less flexible than the structure 3.15 design.

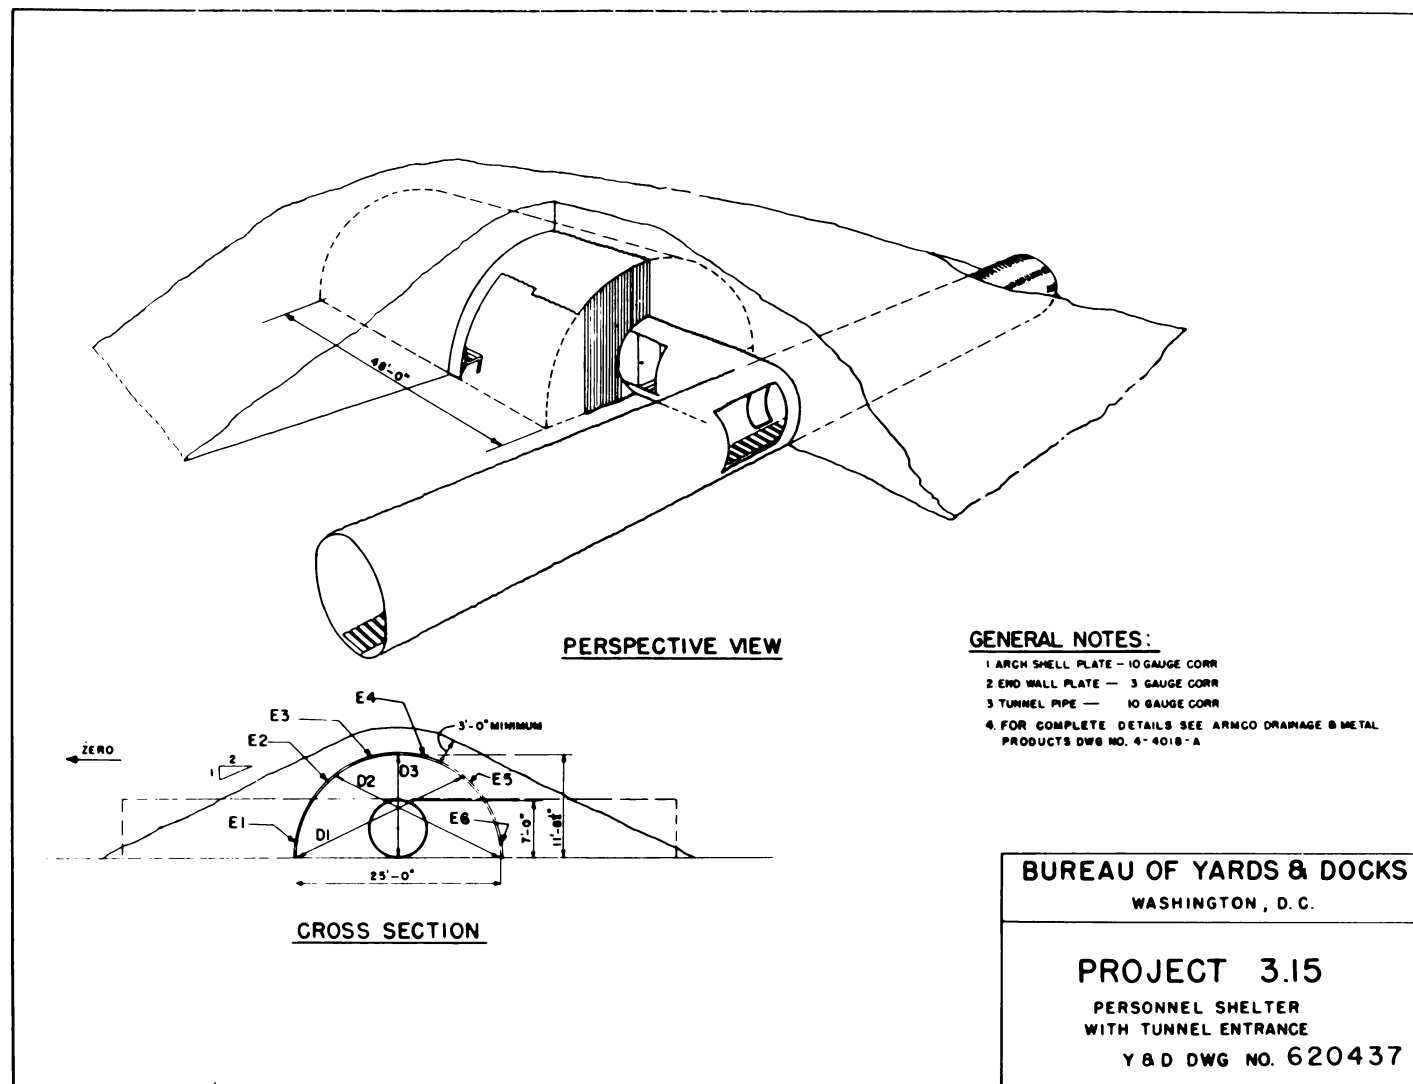
Fig. 3—Details of design, structure 3.15.

Both structures exhibited completely elastic response to shot 9, and only minor permanent deflections were noted. The entrances to both structures were damaged during this shot; the door of structure 3.15 was ripped from its frame and projected about 24 ft into the structure. Maximum side-on overpressure was about 10.8 psi at both structures; however, neither 3.13a nor 3.15 was oriented exactly normal to the blast line.

1. The steel-arch building remained in operational condition and would, except for the doorframe following shot 9, have provided satisfactory protection during these two shots.

6. The doorframe as originally designed failed to withstand a pressure of 11 psi.

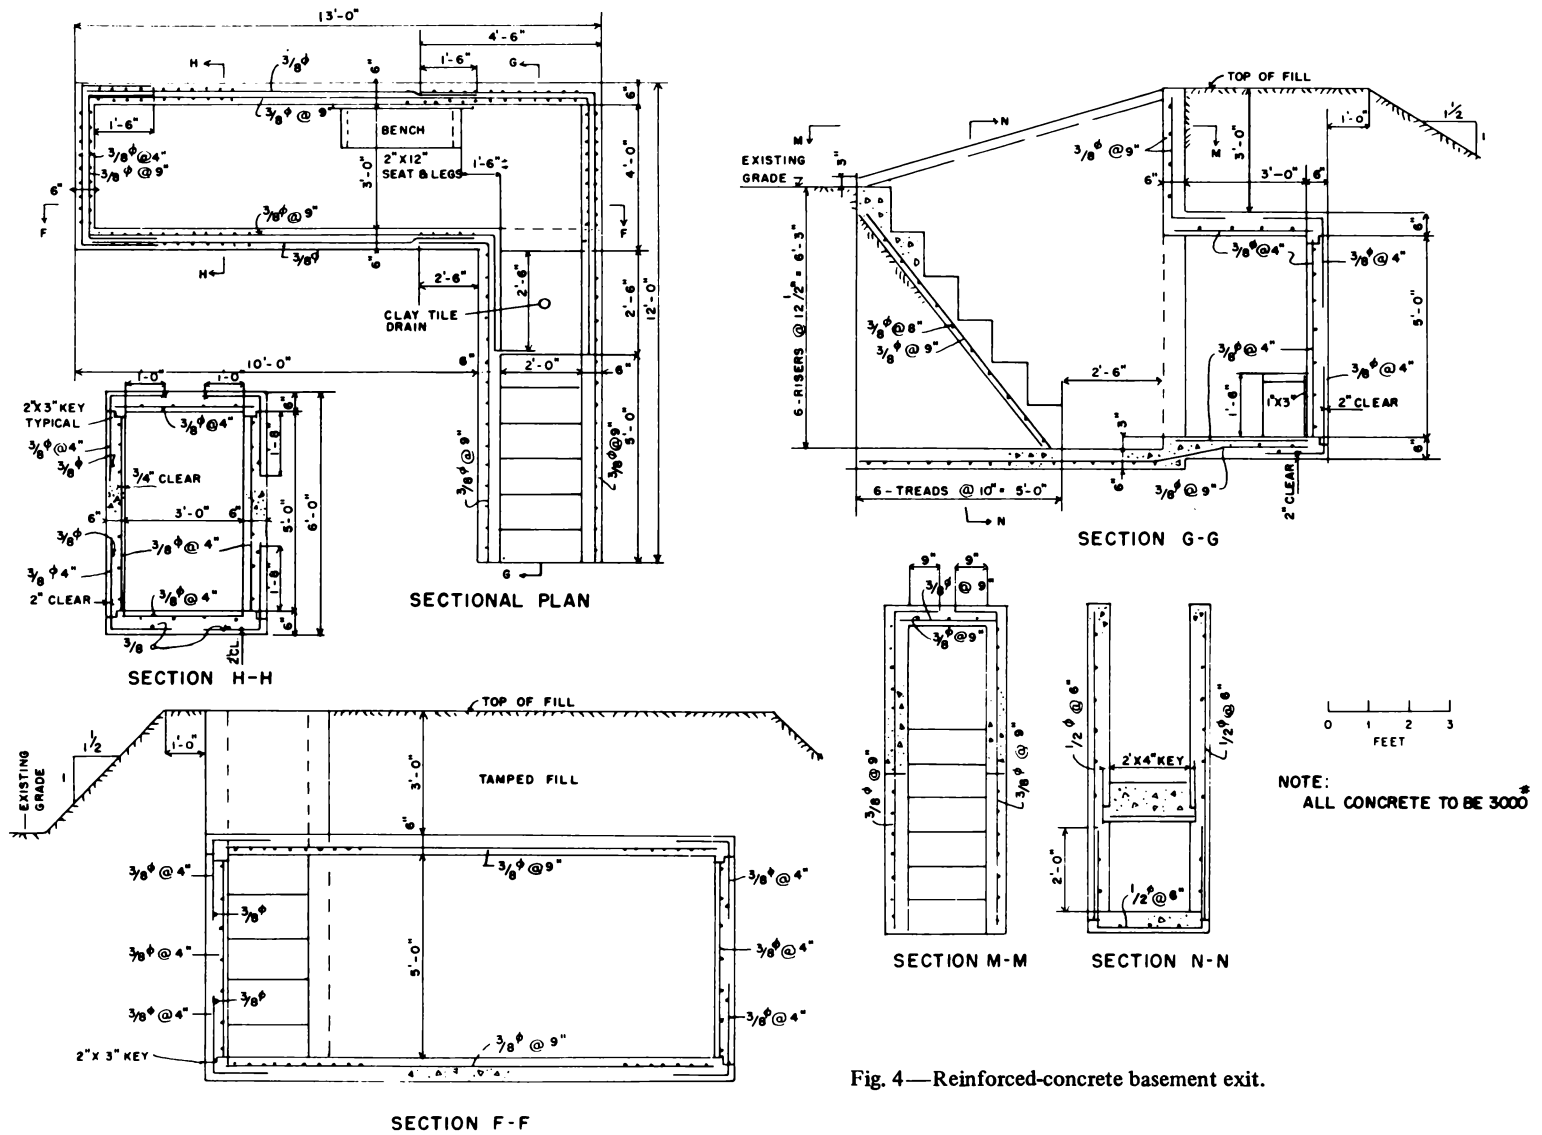
Fig. 4—Reinforced-concrete basement exit.

1. Reinforced-concrete basement exit 1230 ft from GZ (Fig. 4): The roof slab showed no cracks and no permanent deflection. Between the concrete steps and left entrance wall there was a  $\frac{1}{16}$ -in. separation, which extended from the grade to the shelter floor. No other damage to the structure was observed. Inside the shelter the leg of the bench near the entrance was removed by the blast. The child mannequin, although thrown to the floor and partially covered with sand, was undamaged. The adult dummy had separated at the waist when the wood dowel used to connect the upper and lower parts was broken.

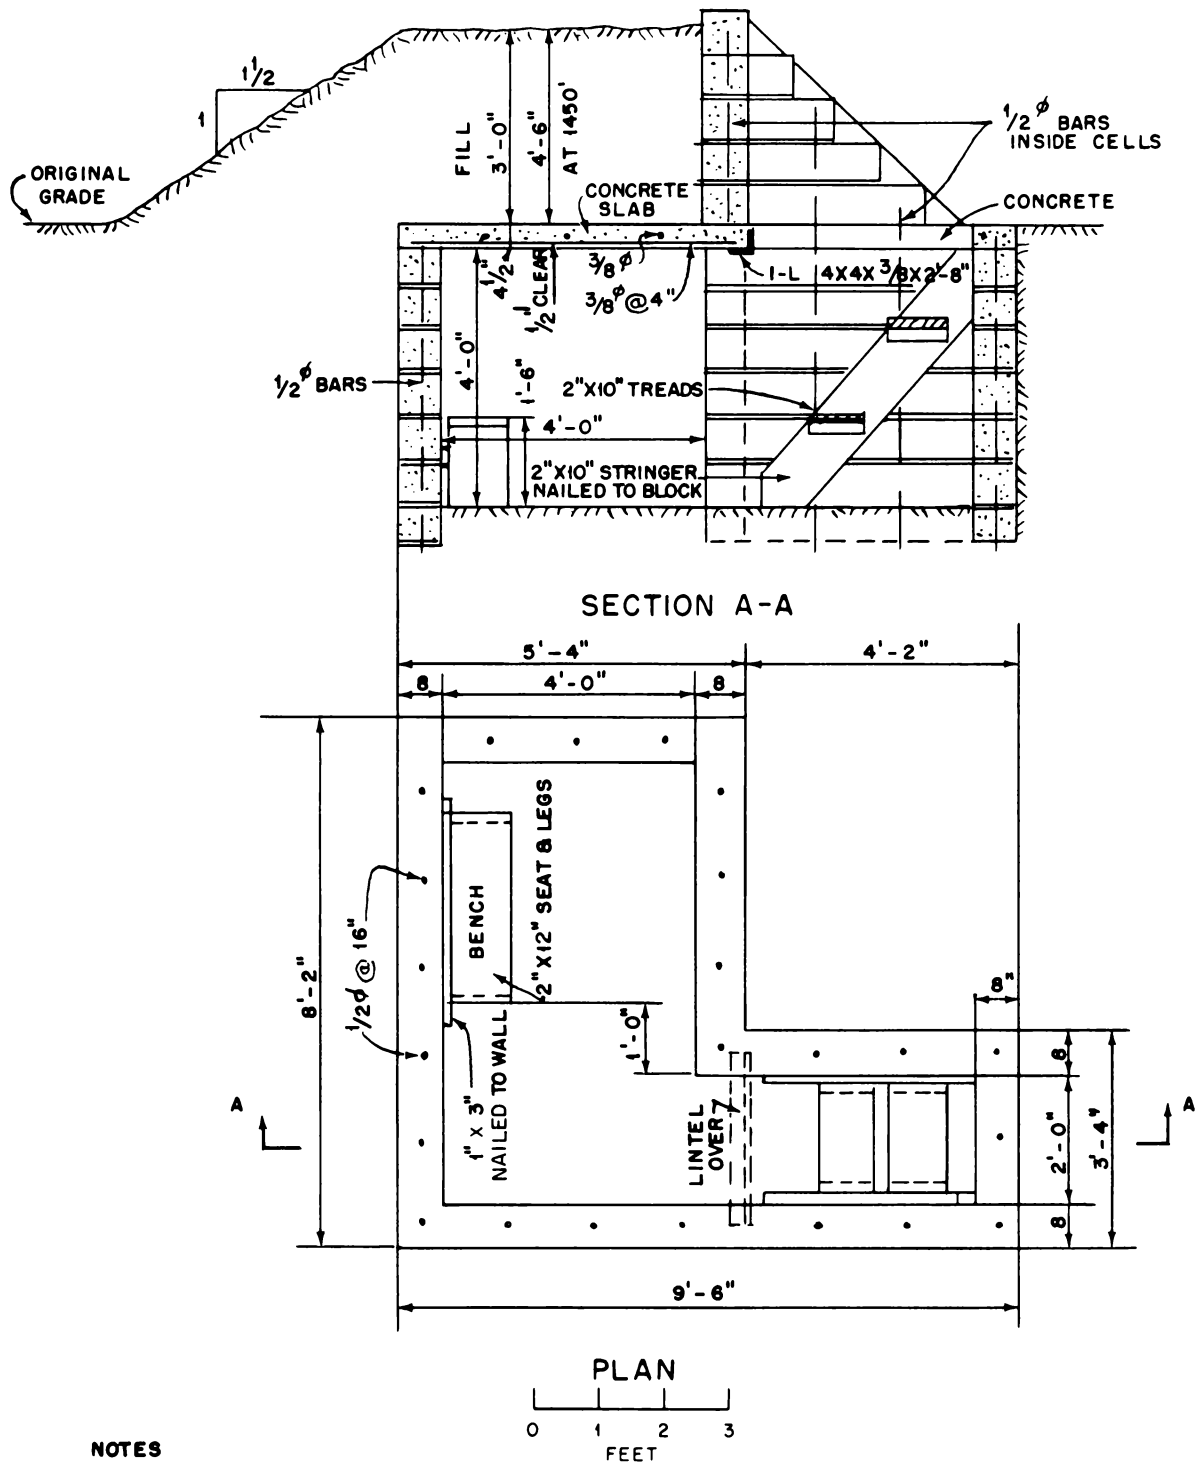
Fig. 5—Earth-covered trench placed at 1450, 1800, and 3500 ft.

2. Earth-covered trench shelters at 1450 and 1800 ft from GZ (Fig. 5): In each shelter an 84-lb mannequin was not moved or damaged by the blast. No damage to the shelter was evident. The roof slabs showed no cracks and had no permanent deflection at midspan.

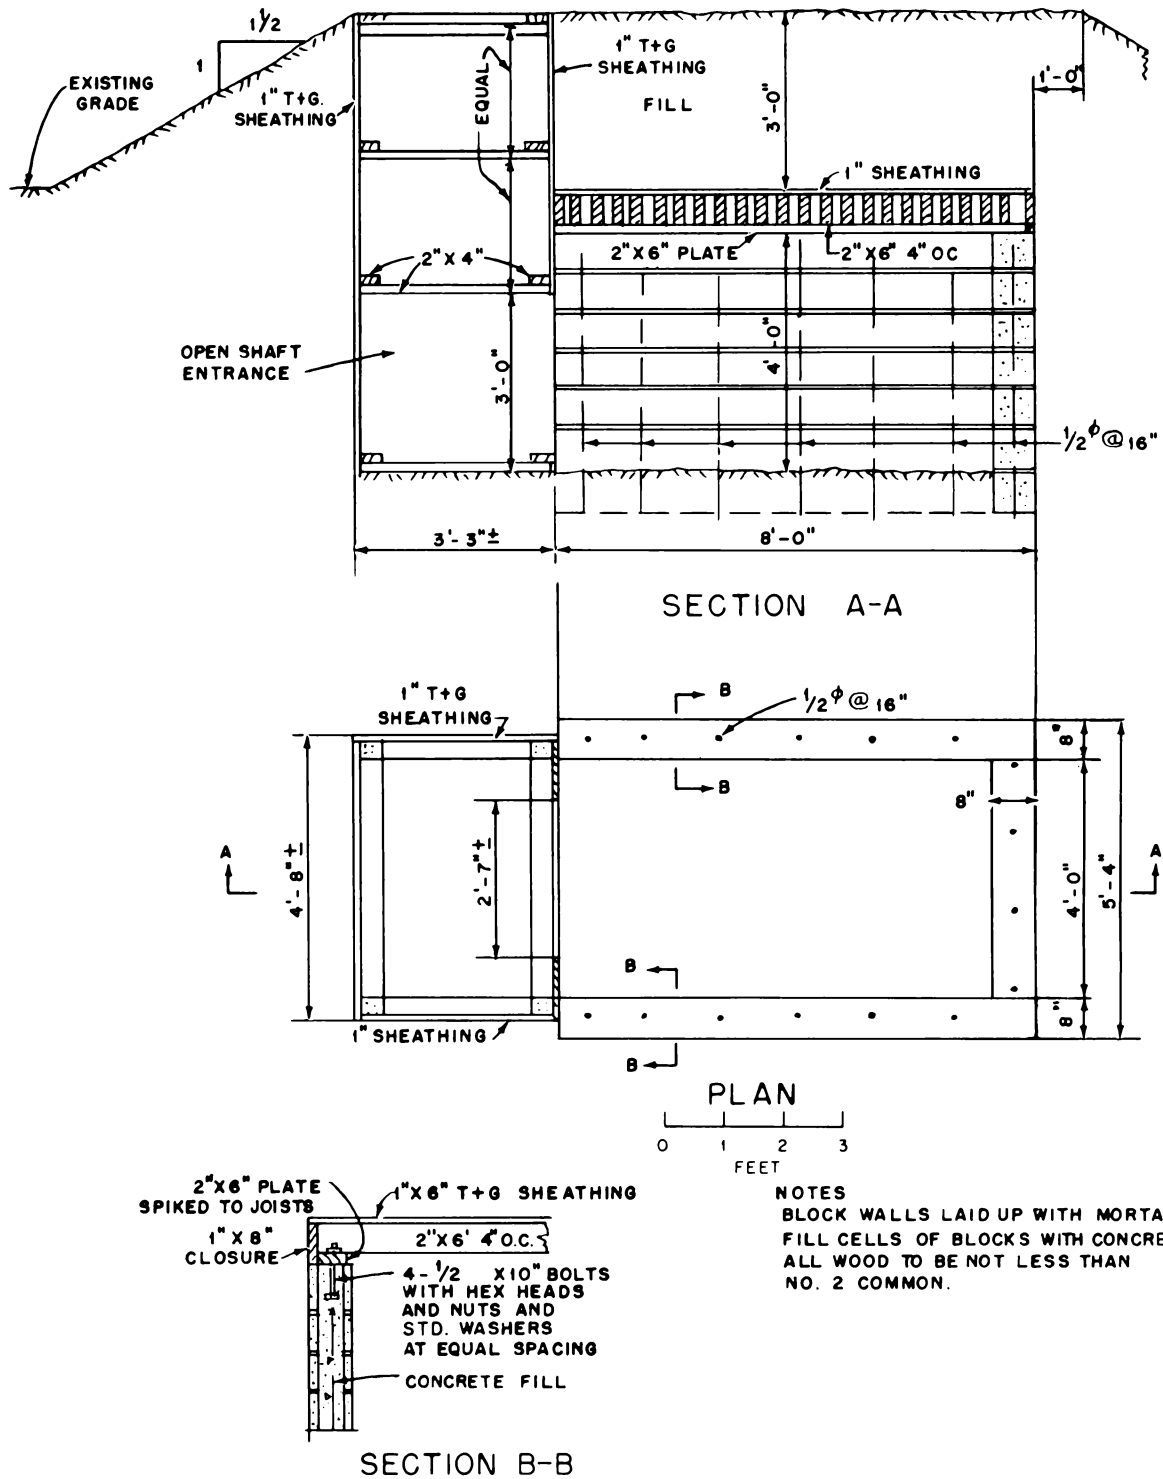
Fig. 6—Wood-covered trench.

3. Wood-covered trench shelter with open shaft entrance at 1800 ft from GZ (Fig. 6): A break in one of the longitudinal block walls about midway between the end wall and the entrance was attributed to faulty construction. The roof joists suffered no damage; the experimental shaft entrance, however, was considerably damaged.

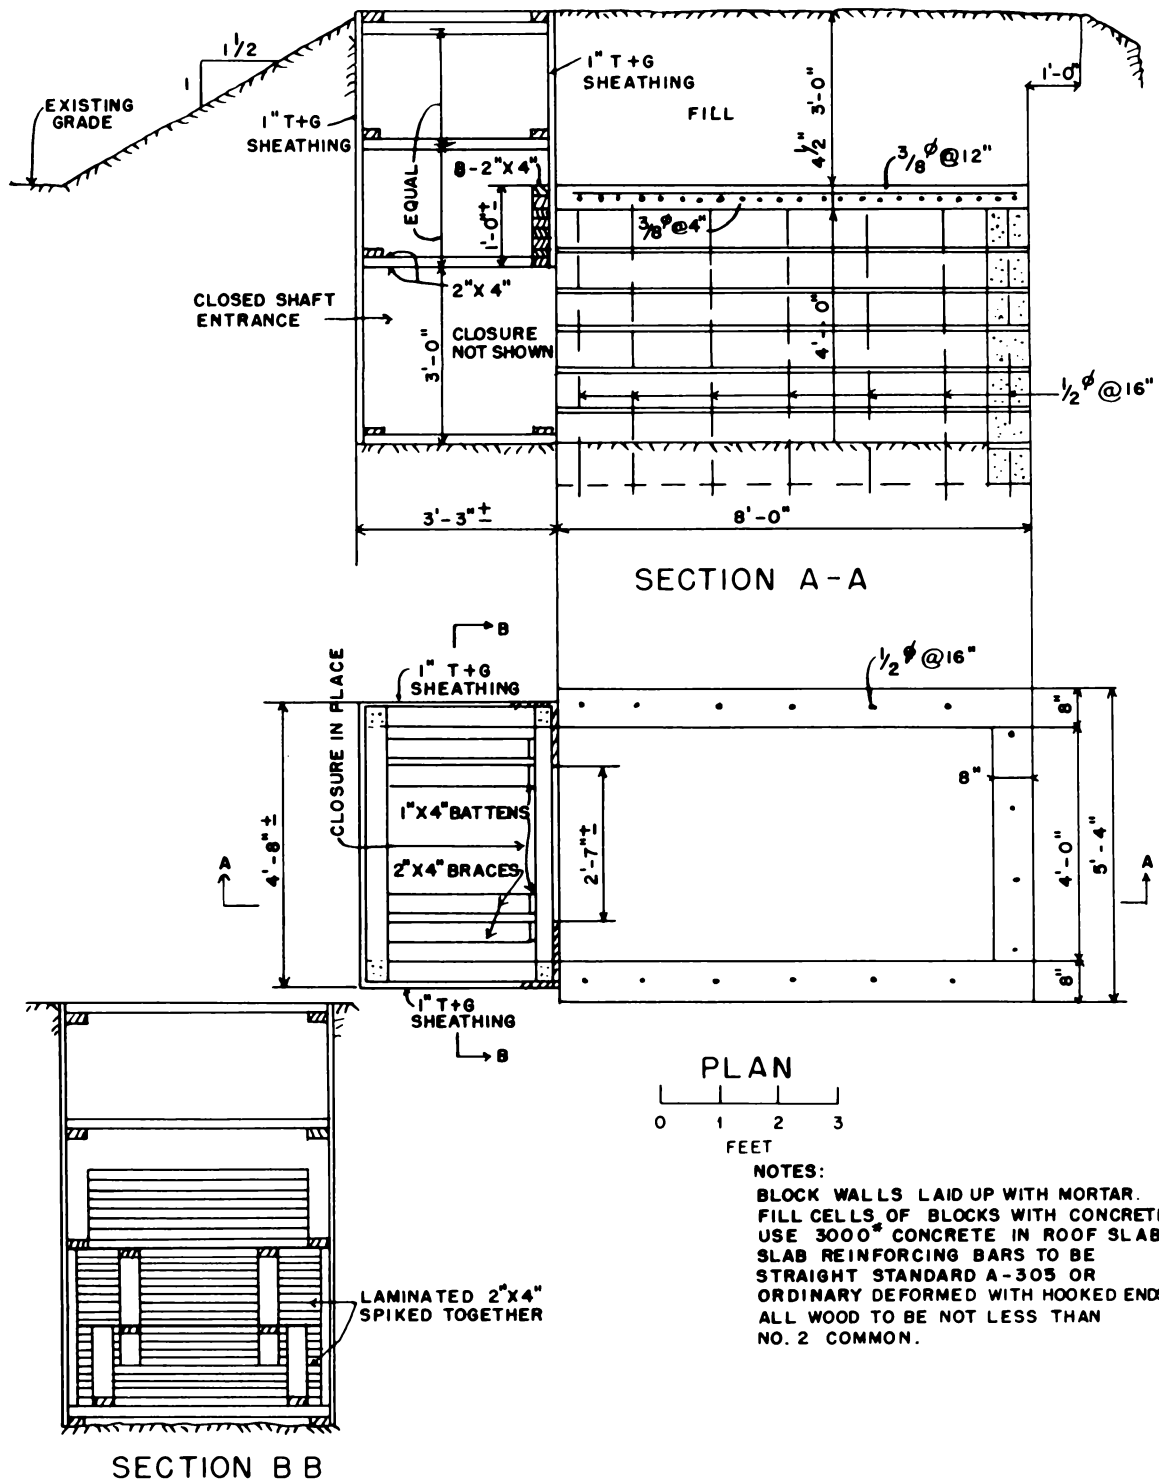
Fig. 7—Earth-covered trench with closed shaft entrance.

4. Earth-covered trench shelter with closed shaft entrance (Fig. 7), block-wall basement exit structure, and concrete-pipe shelter with closed shaft entrance: All were 1800 ft from GZ and suffered no significant interior or exterior damage.

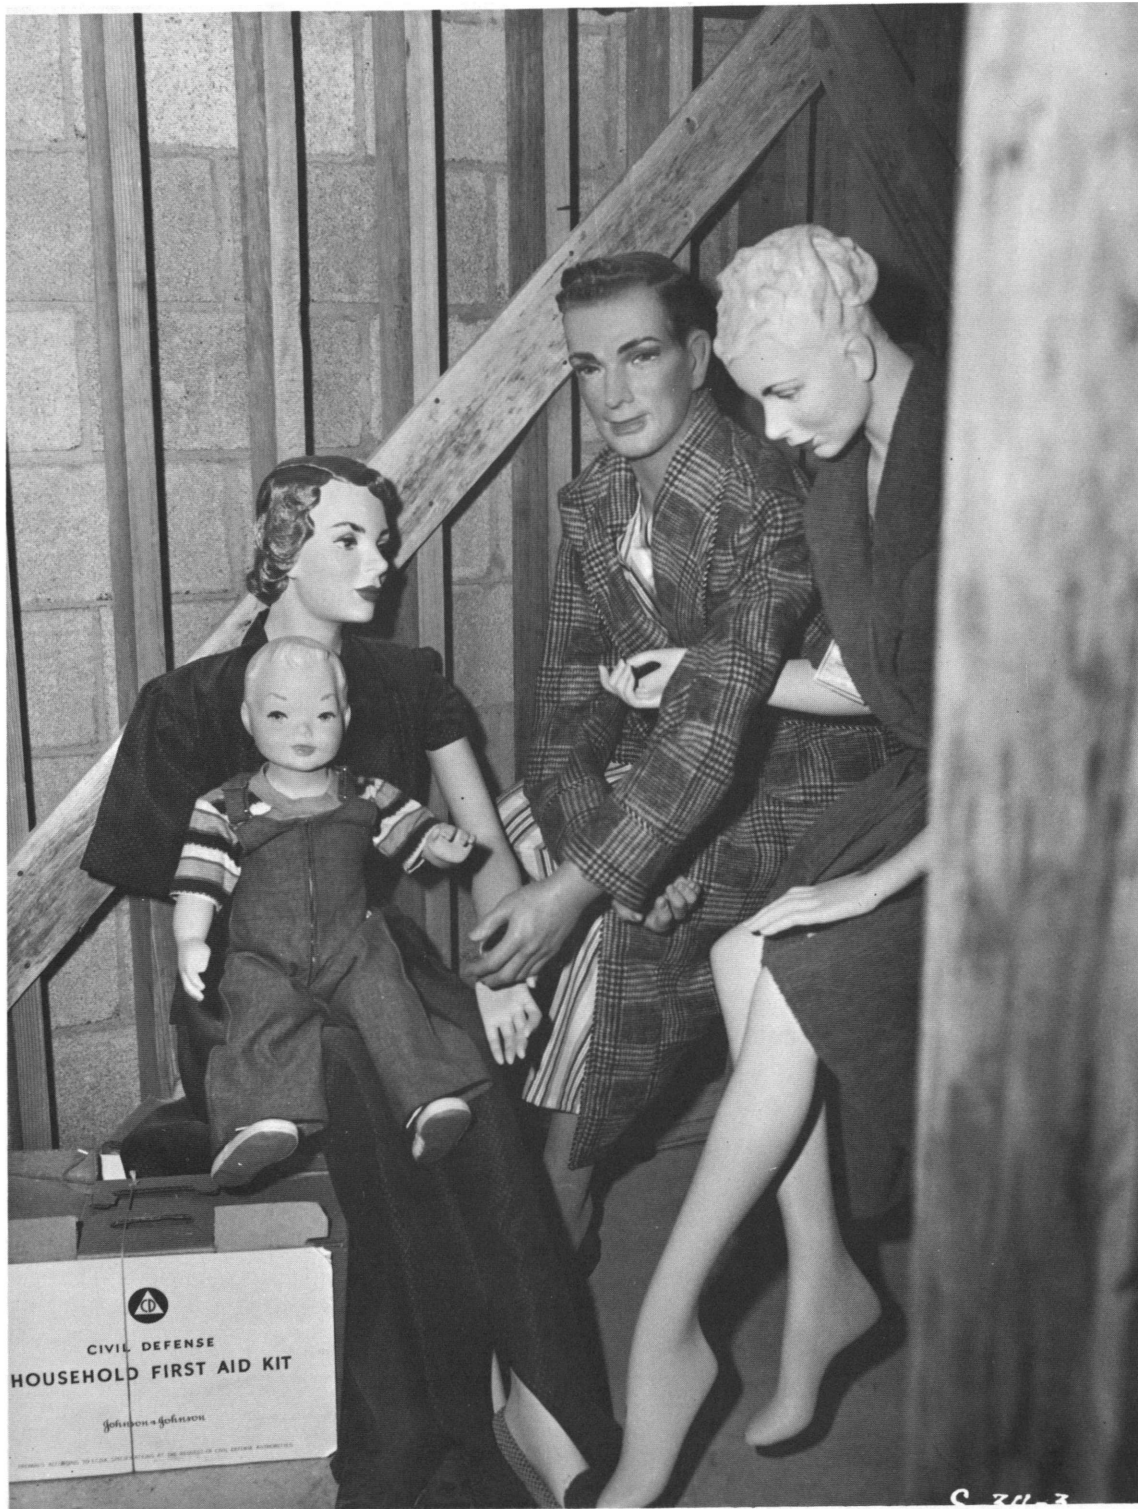
Fig. 9—Basement corner room (at 7500 ft) after blast.

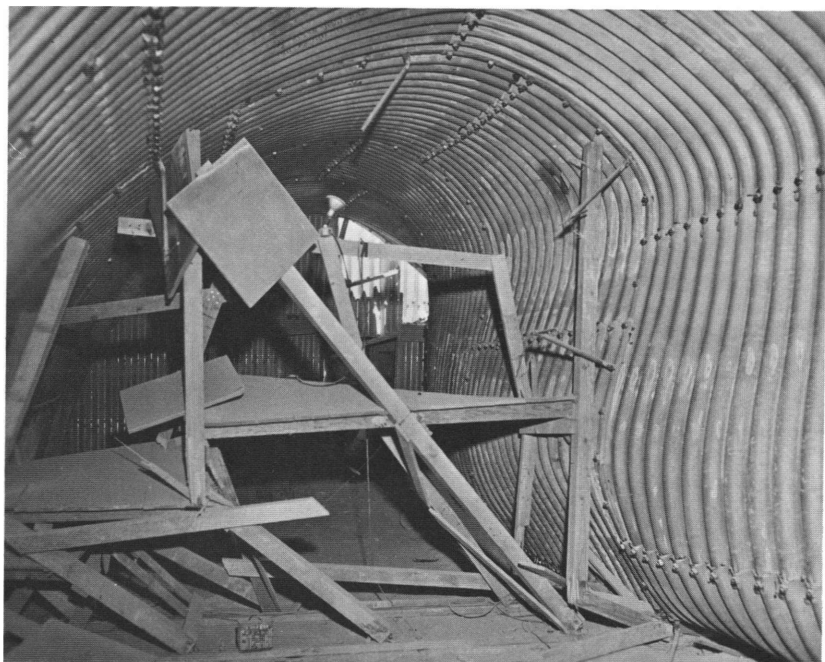
The physical results of this test, particularly the pressures measured on the windward slope compared with the free-field measurements, together with the fact that building 3.6 collapsed, demonstrate that a structure of this type and shape is, from a blast-damage standpoint, primarily a drag-type or a dynamic-pressure ( $q$ ) sensitive rather than an overpressure ( $p$ ) sensitive target. Drag forces will be reduced by reducing the height of the earth berm until these forces become zero for complete burial of the structure. Resistance to both  $q$  and  $p$  forces would be enhanced by increasing the gauge of the corrugated steel, increasing the depth of corrugation, decreasing the span of the arch, stabilizing the soil used for cover, and widening the earth berm.

**Fig. 5—Interior of building 3.6 after shot.**

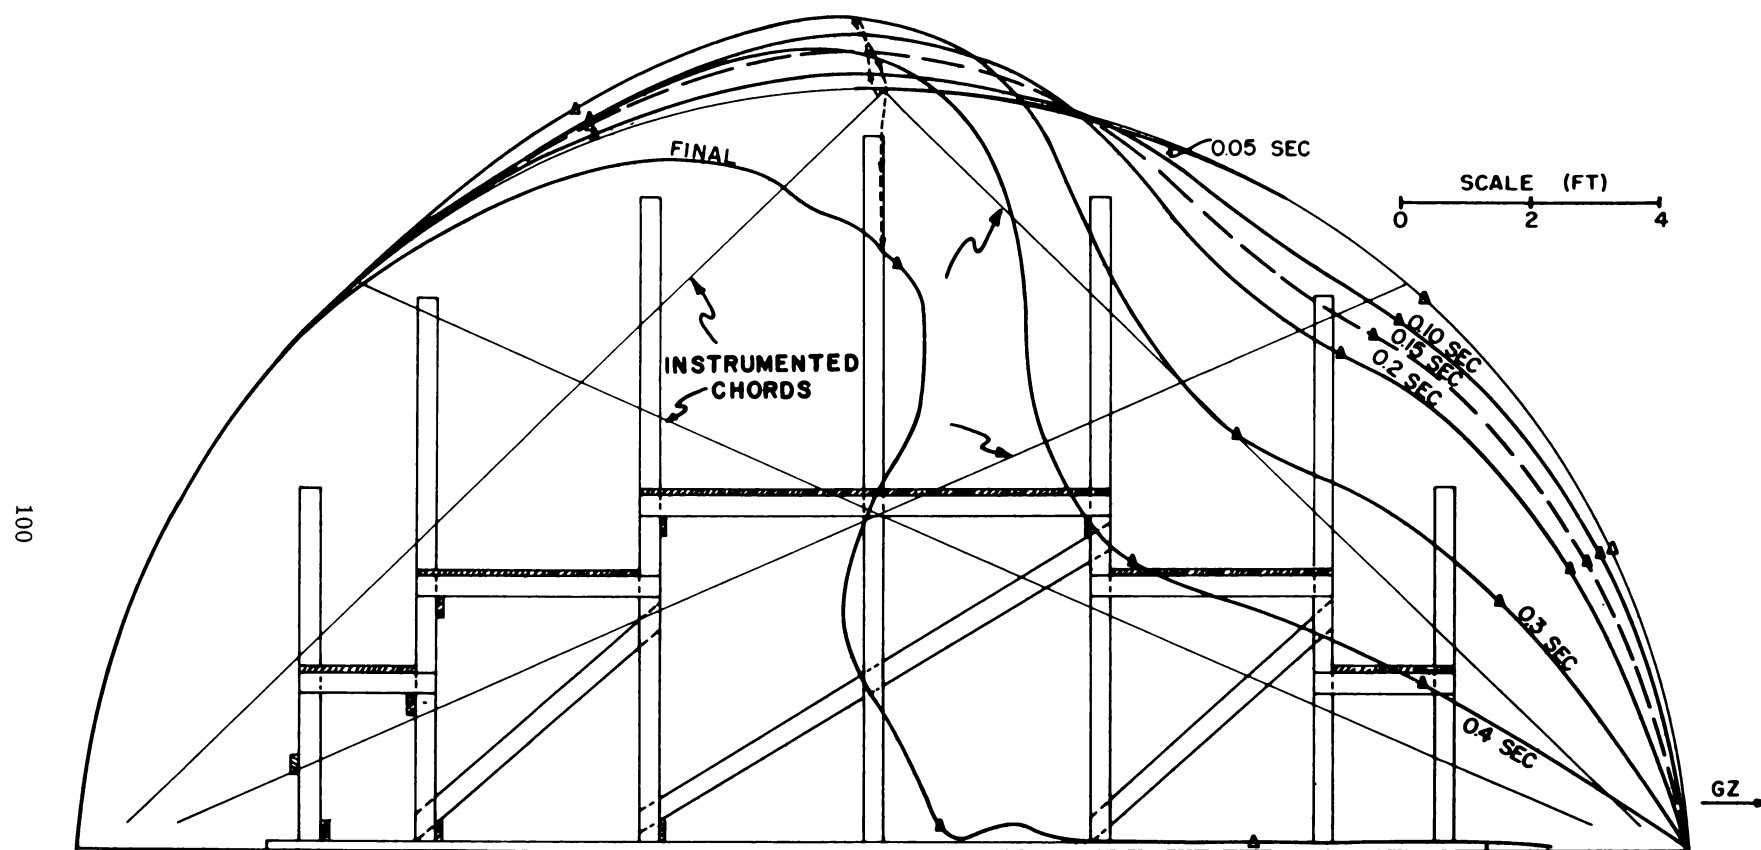
Fig. 6—Profile at various times, building 3.6.

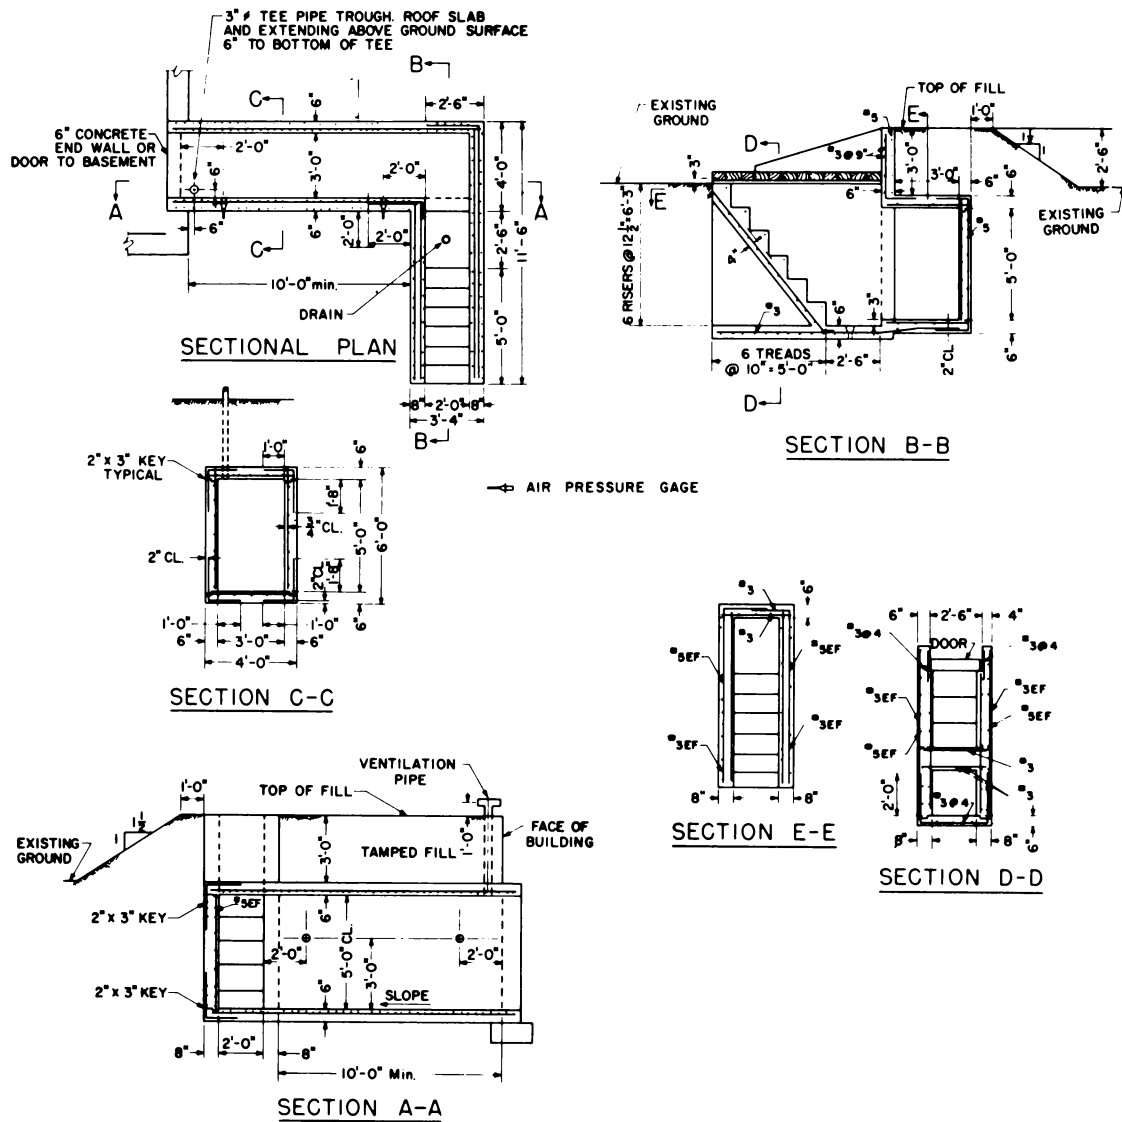
BASEMENT-EXIT SHELTERS. *Shot Apple I (Stations 4–34.1 b-1, b-2, b-3 at 1350 ft)*. The closed, partially closed, and open shelters suffered moderate, serious, and severe damage, respectively, caused by an excess of interior over exterior pressure on the walls. Retaining walls failed, exposing reinforcing steel in some places. Shelter walls cracked from tension in the closed and partially closed shelters; in the open shelter the walls either separated from the roof and floor or were badly cracked. Doors on the closed and partially closed shelters failed, indicating that a stronger rebound device would be required. All shelters were littered with dirt and missiles.

*Shot Apple II (Stations 1–34.1 c-1, c-2, d-1, d-2)*. Closed shelters at 1270 ft sustained severe structural damage. All doors blew off in the positive phase, and rebound locks and retaining walls failed under a pressure of 45 psi. Interior walls were cracked and had outward deformations caused by an unbalance of interior over exterior pressure.

Fig. 11—Details of basement-exit shelter, stations 4-34.1 b, 1-34.1 c, and 1-34.1 d.

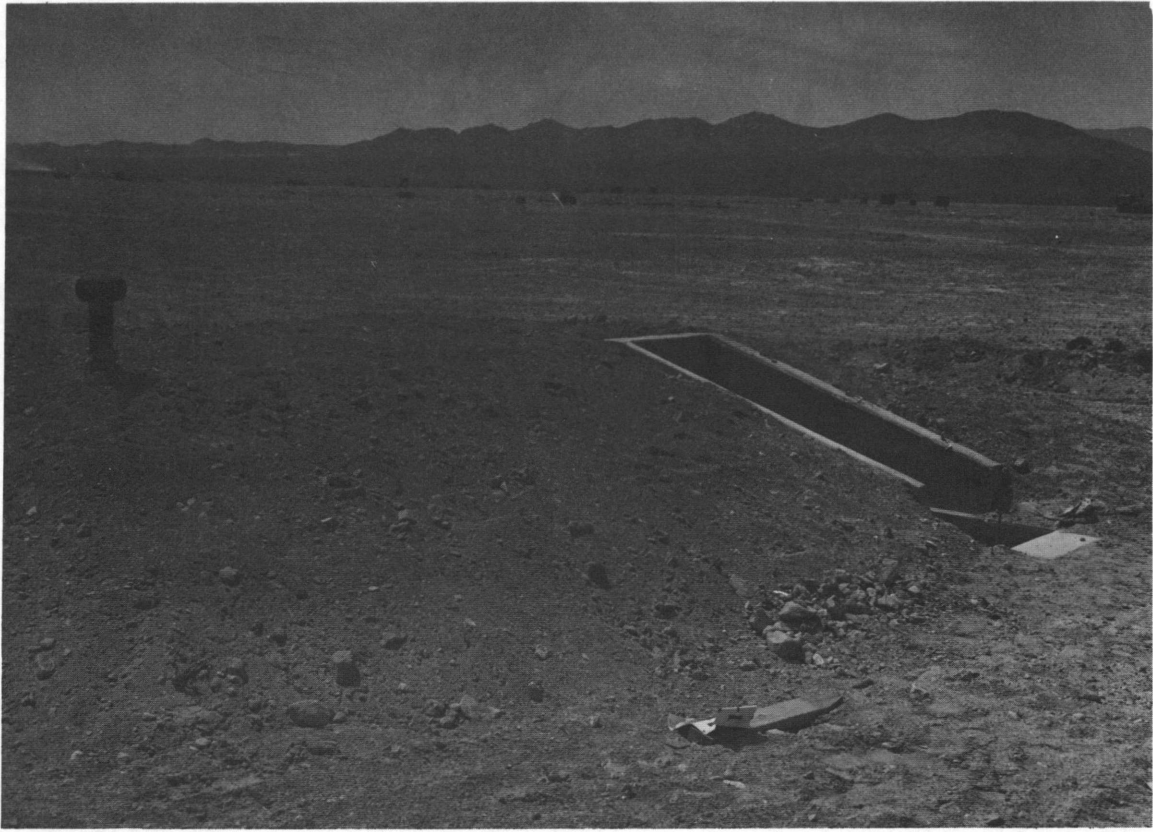
Closed shelters at 1470 ft suffered little interior damage, but all doors and retaining walls failed, apparently during the negative phase.

Damage to open shelters at 1270 and 1470 ft was severe and moderate, respectively. From each structure some earth cover was blown away, and vent pipes were either blown away or bent.

Fig. 12—Exterior of basement-exit shelter, stations 4-34.1 b, 1-34.1 c, and 1-34.1 d.

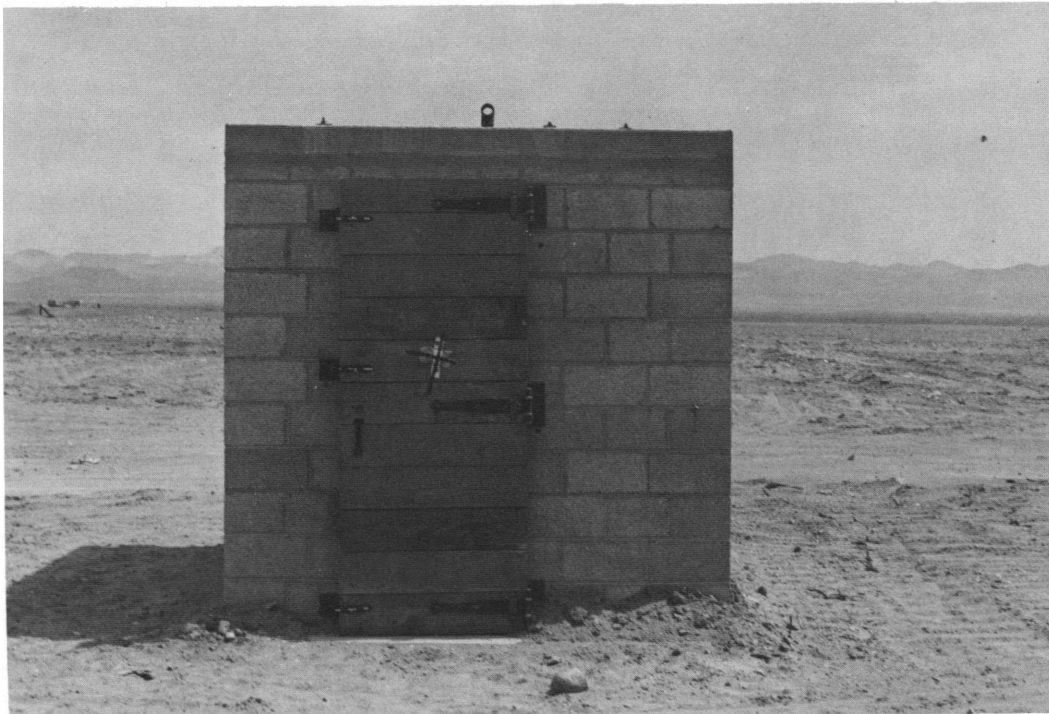
UTILITY-TYPE SHELTERS. *Shot Apple II (Stations 1–34.1 e,f,g at 2250 ft)*. The masonry shelter disintegrated. The poured-in-place reinforced-concrete shelter remained intact. It was displaced and came to rest on its side 50 ft from its original position. The precast reinforced-concrete shelter failed severely. Door fastenings failed on the poured-in-place structure, and the doors on the precast shelter blew away.

Fig. 15—Exterior of masonry utility-type shelter, stations 1–34.1 g, j, and m.
